## **IN-SITU METALLOGRAPHY FOR THE PLANT HEALTH ASSESSMENT STUDY AND FAILURE INVESTIGATION**

Virendra K. Bafna and Paresh U. Haribhakti  
TCR Engineering Services Pvt. Ltd.  
Mumbai, India

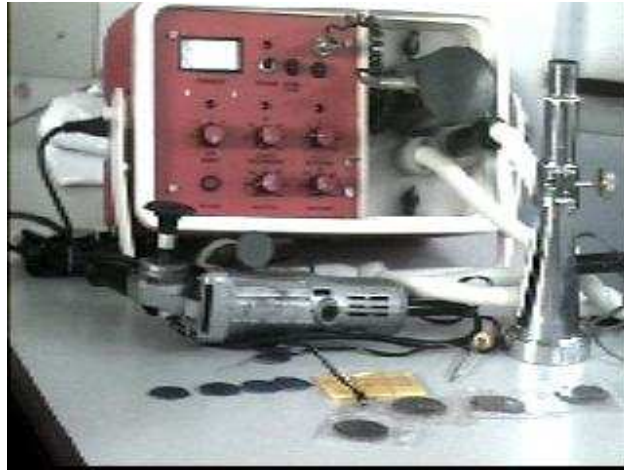
Photo. 1 shows the in situ metallography kit comprises of portable electrolytic ether/polisher with portable grinder and microscope.

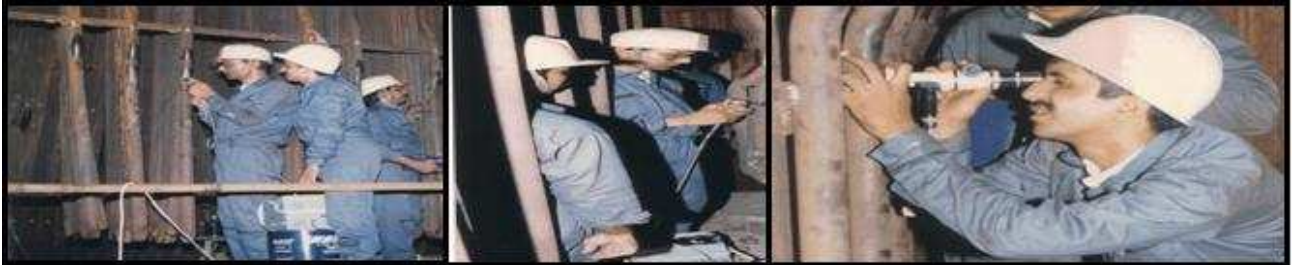
Photo: 2 The actual process of in-situ metallography under progress in side Boiler.

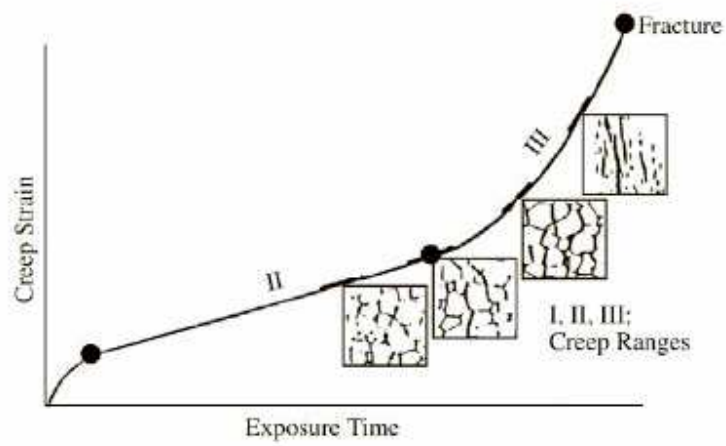
Sketch:3 Different stage of creep along with microstructure degradation stages

Class	Damage	Recommendations precautions
1	No creep cavities	None
2	Single cavities	Re-Examine after approximate 20000 hours of operation
3	Coherent cavities	Re-Examine after approximate 15000 hours of operation
4	Creep cracks (Micro)	Re-Examine after approximate 10000 hours of operation
5	Creep cracks (Macro)	The plant is contacted immediately
